Manhole Inspection Summary

Manhole # S15KK1019MH

Location Address: **4553 THE STRAND**

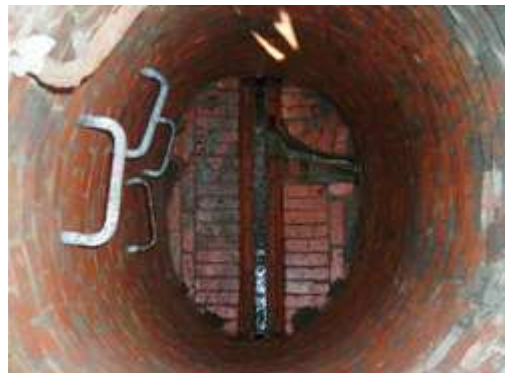
Top View

Corroded and missing steps. Evidence of surcharge - Bench debris.

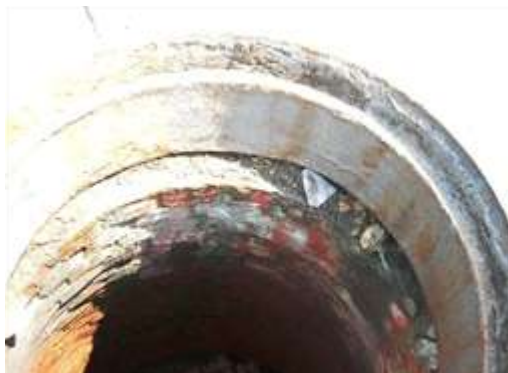
Defect

Frame leaks. Frame offset. Adjustment deterioration, loose brick and infiltration.

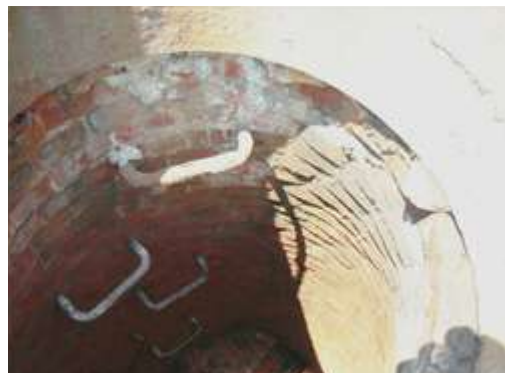
Defect

Frame leaks. Adjustment deterioration, loose brick and infiltration. Corbel and Barrel infiltration.

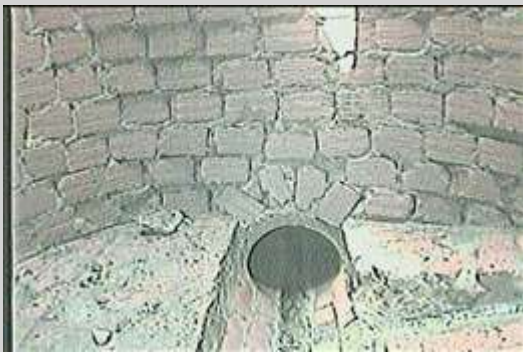
8 in. Circular Gravity Sewer Pipe Out @ 12 O'Clock

Barrel deterioration and infiltration. Channel deterioration.

Infiltration: **Evidence** Pipe Seal Cond: **Unknown**

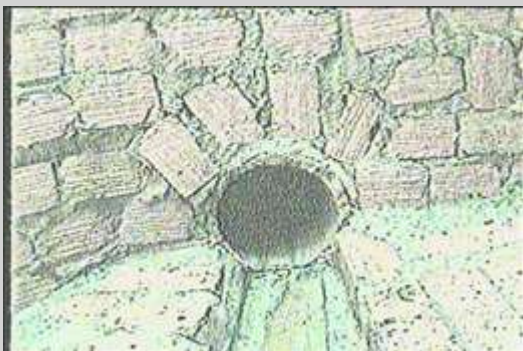
6 in. Circular Gravity Sewer Pipe In @ 3 O'Clock

Barrel deterioration and infiltration. Channel deterioration.

Infiltration: **Evidence** Pipe Seal Cond: **Unknown**

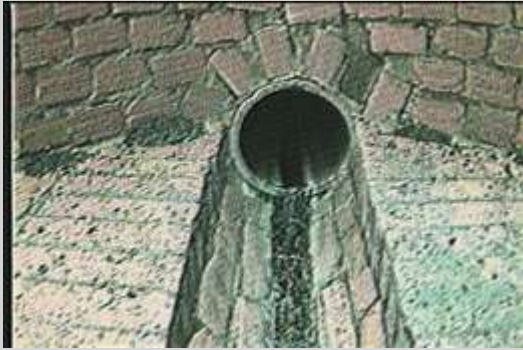
8 in. Circular Gravity Sewer

Barrel deterioration and infiltration. Channel deterioration.
